ARTIFICIAL JOINTS: THEIR TRIBOLOGY AND WEAR PARTICLE ANALYSIS

Artificial Joints: Their Tribology and Wear Particle Analysis

Submitted for the degree of Doctor of Philosophy.

Centre for Biomedical Engineering

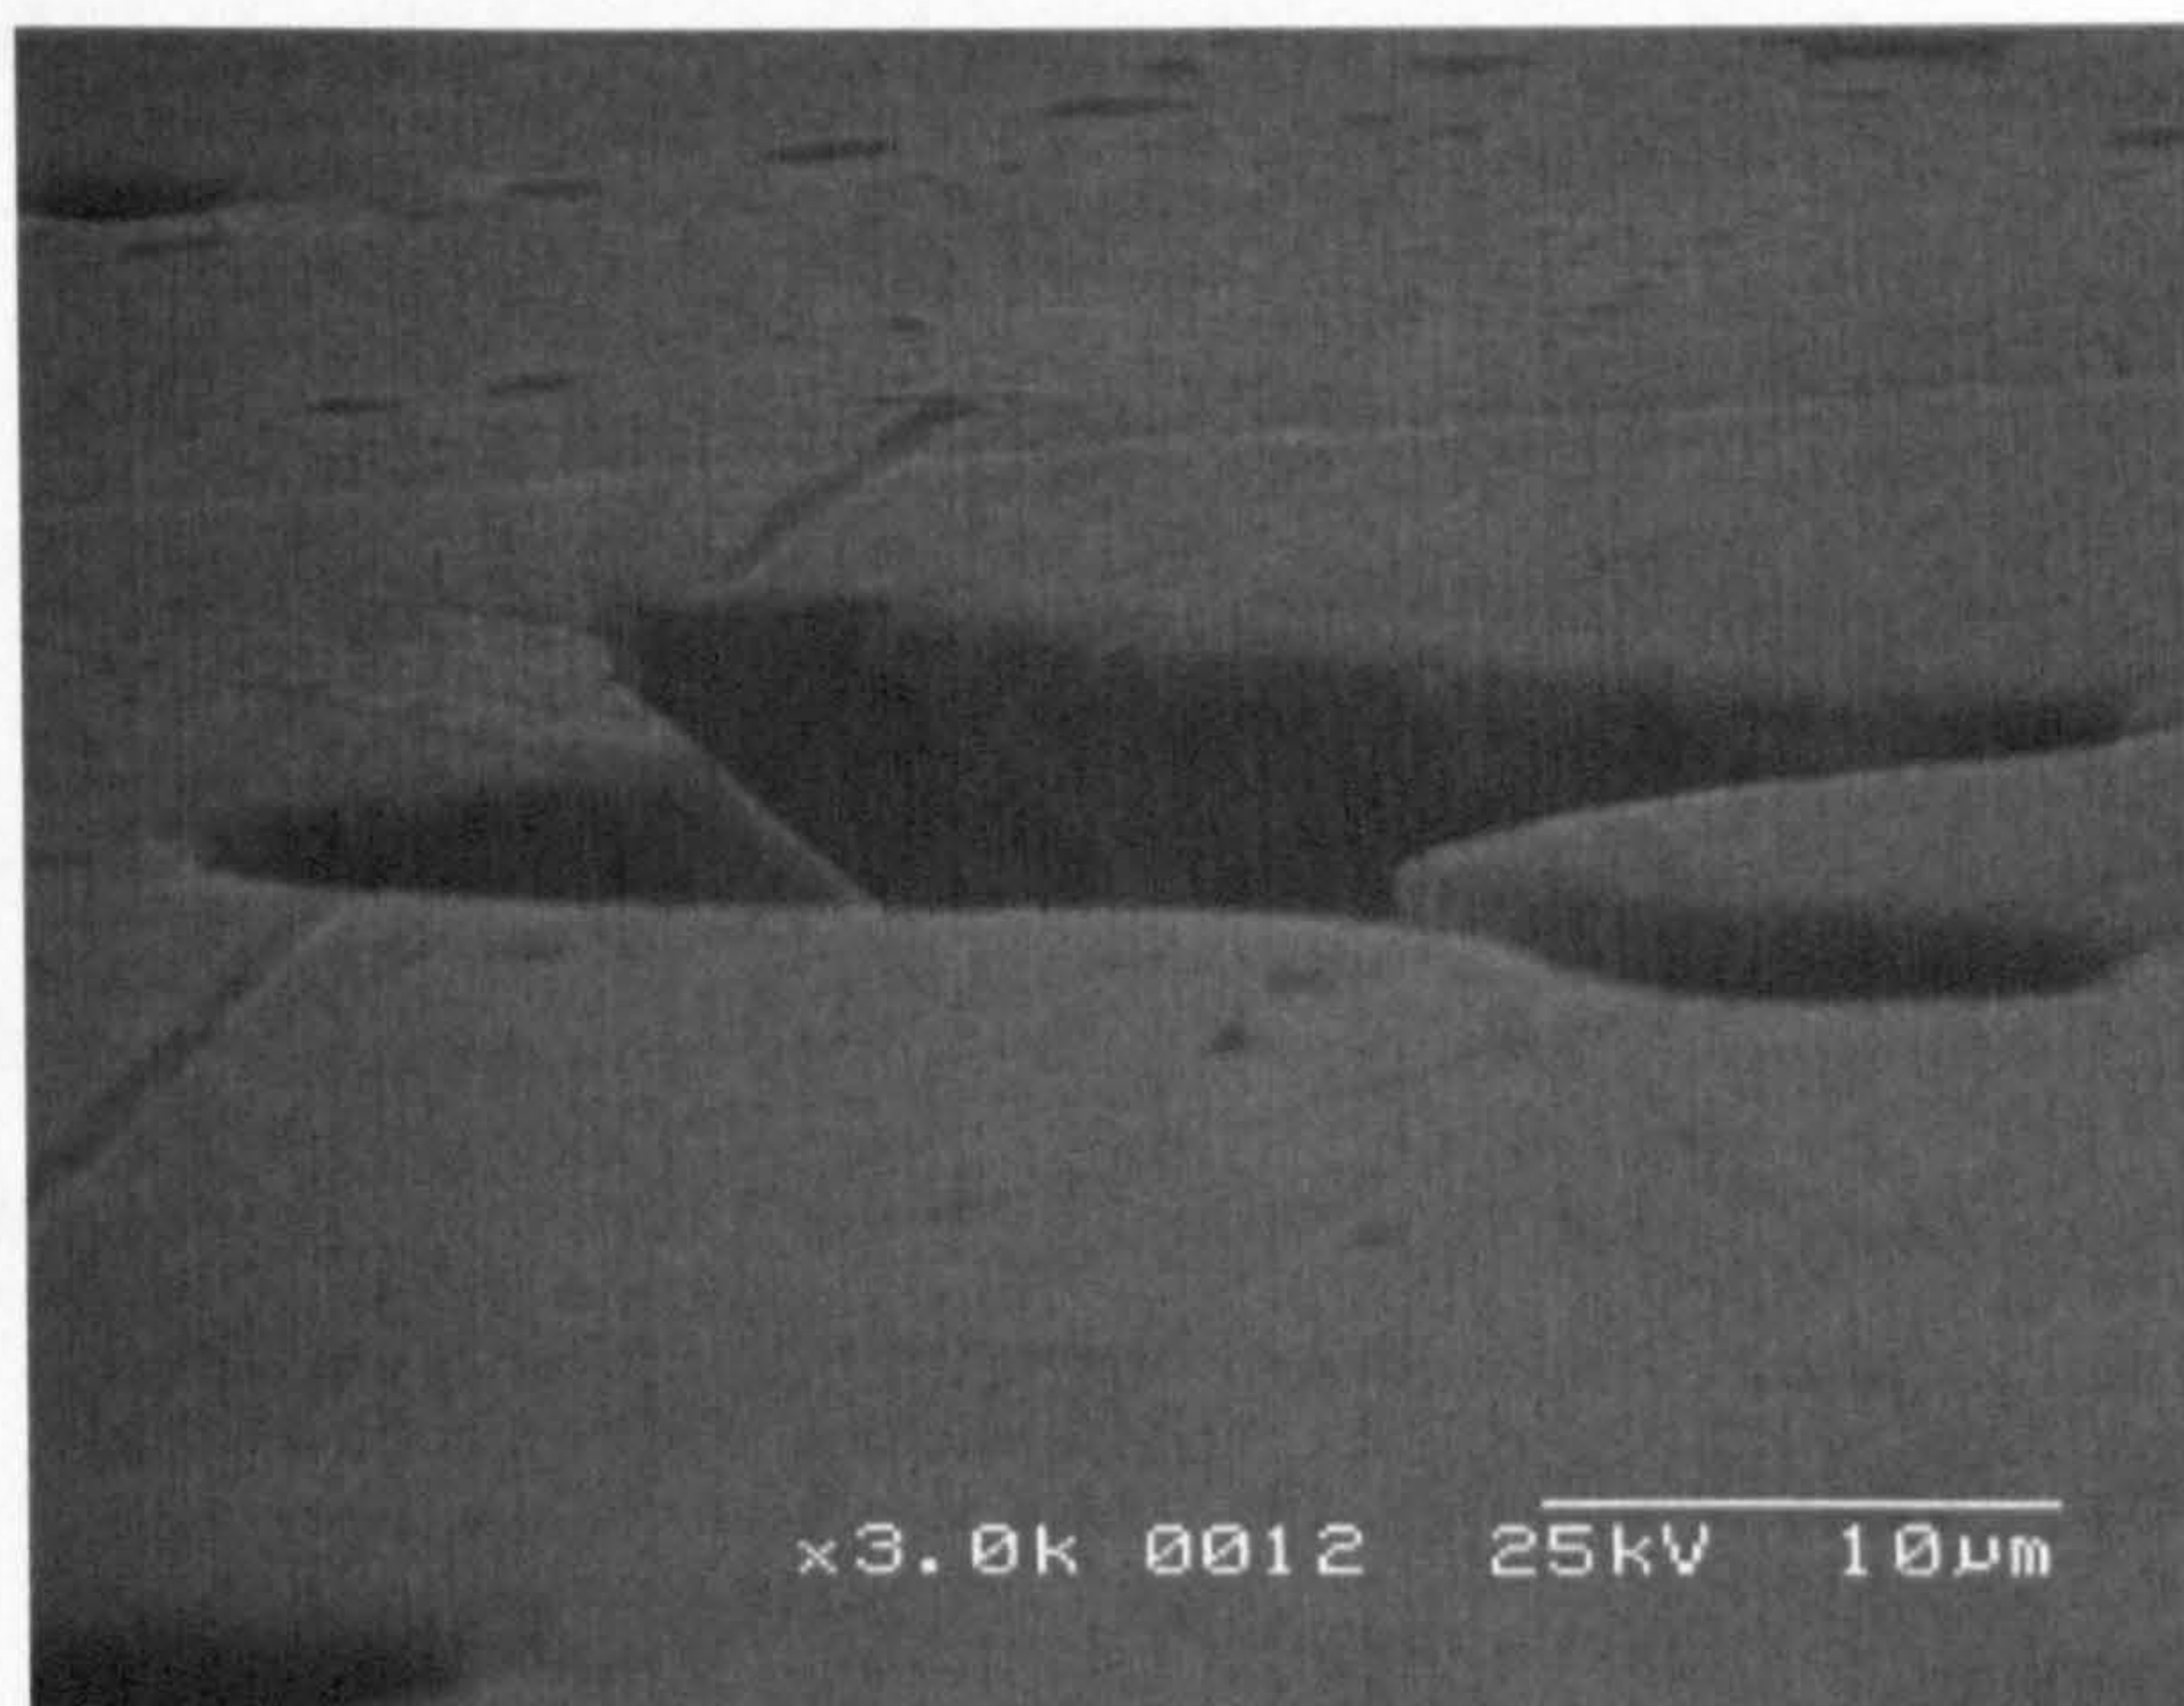
Figure 37 high magnification image of a hole created in the double heat treated specimen during wearing

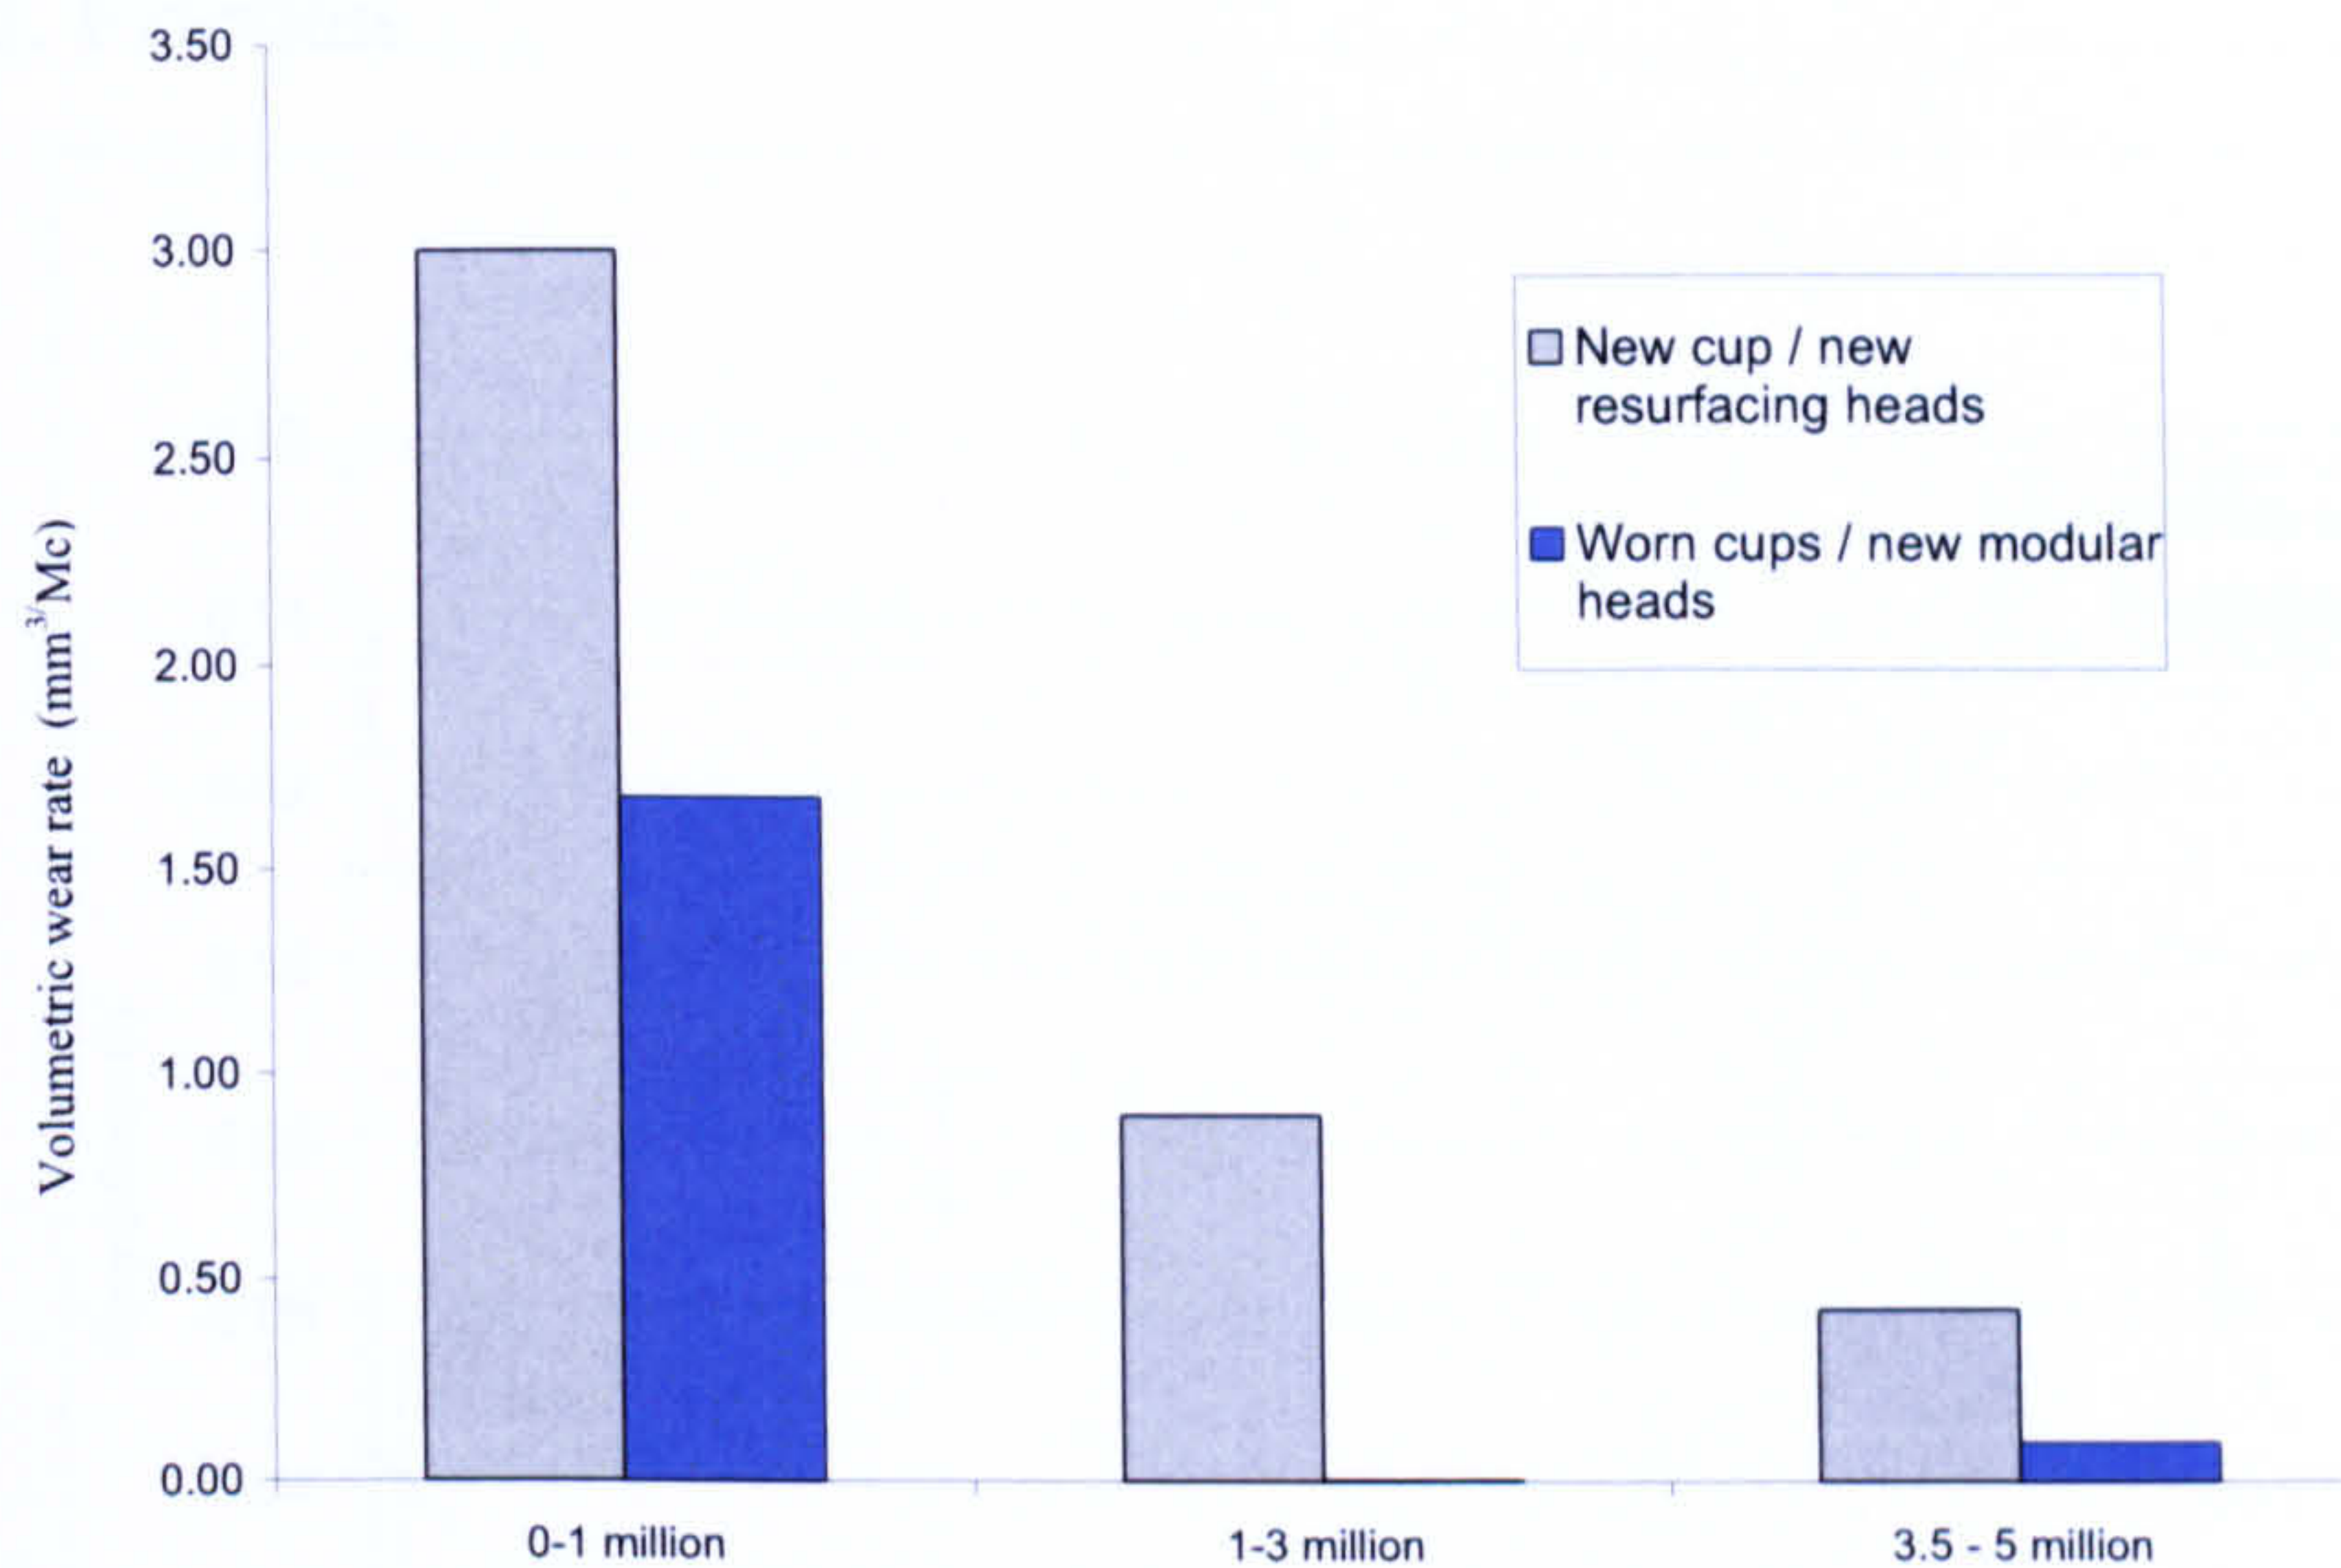
Figure 55 Comparison of wear rate for the new cups against new heads and old cups against new heads
